# Haiti Mission Report

20 January - 19 March 2010

MURALEE THUMMARUKUDY  
PROGRAMME OFFICER, POST CONFLICT AND DISASTER MANAGEMENT BRANCH  
UNITED NATIONS ENVIRONMENT PROGRAMME

March 2010

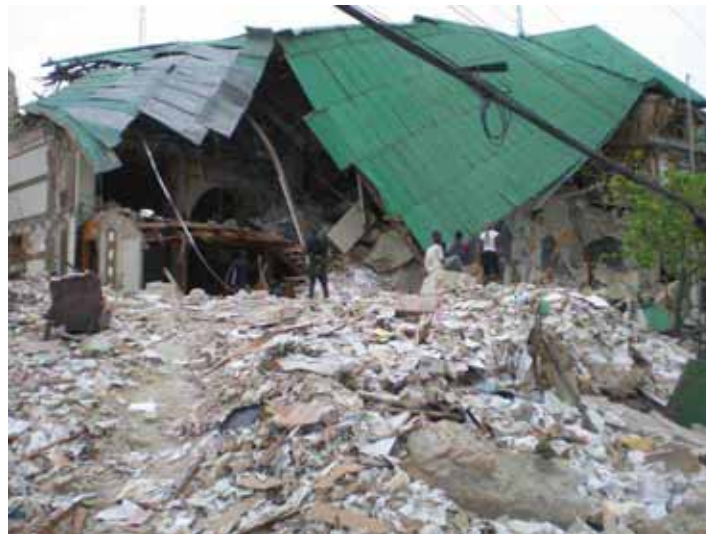
The Haitian Government infrastructure was seriously impacted by the earthquake; above, the remains of the Ministry of Environment.

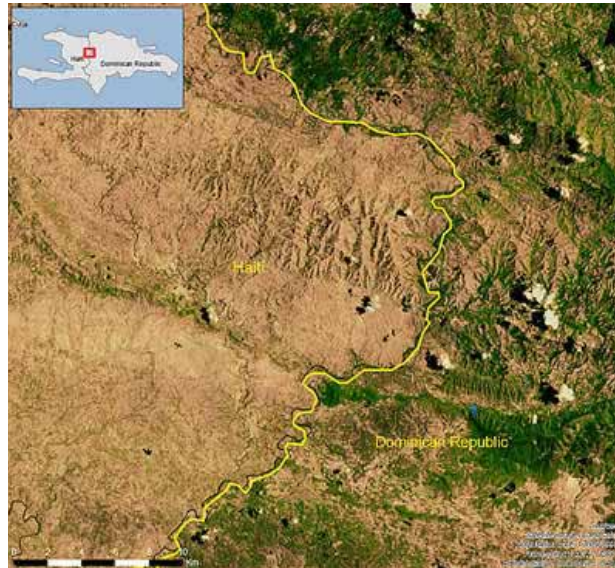
Severe deforestation in Haiti is clearly contrasted with the forest cover across the border in the Dominican Republic.

As a result, Haiti suffered significantly more than its neighbour the Dominican Republic during the frequent cyclones and tropical storms that hit the Island of Hispaniola, and in the rainy seasons. A cursory look at a “Google Earth” image of the island shows a clear contrast between the eastern and western parts. The eastern two thirds appear green (covered in forests and vegetation), while the western third appears almost completely brown (heavily deforested). Flying over the island, the contrast is even more striking. Not only are there more trees in the eastern part, but one can also see a better network of roads and transport infrastructure. In addition, no siltation from rivers – which makes the sea appear brown at the estuary – is visible.

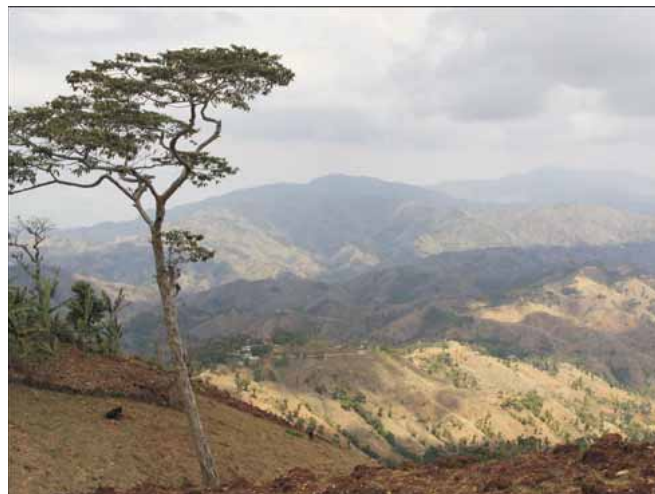
Extensive deforestation and erosion greatly exacerbated physical vulnerability to the January 12 earthquake.

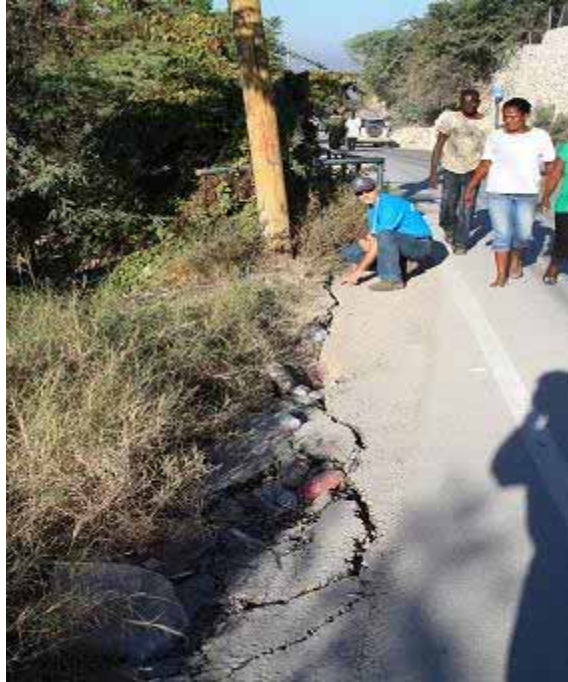
A UNEP expert inspects road damage in the days following the earthquake.

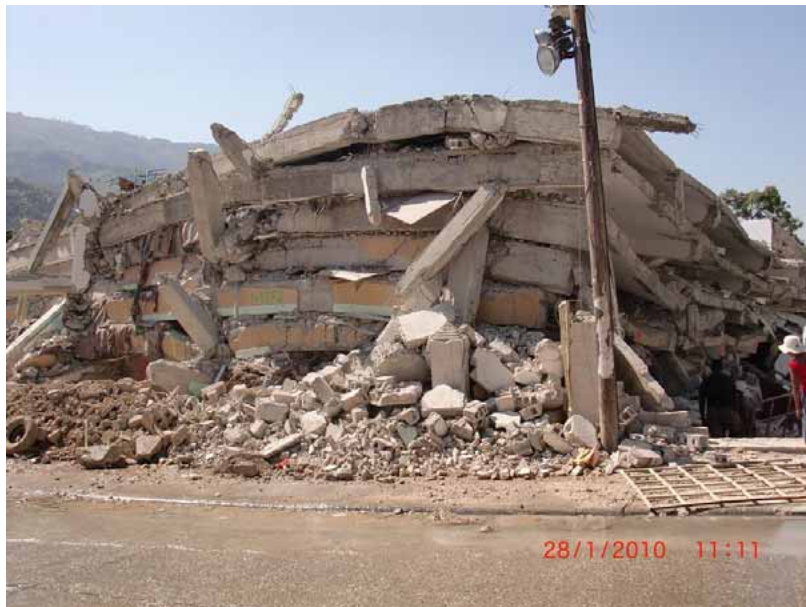
The earthquake caused multiple building storeys to crumble onto each other, compacting everything within.

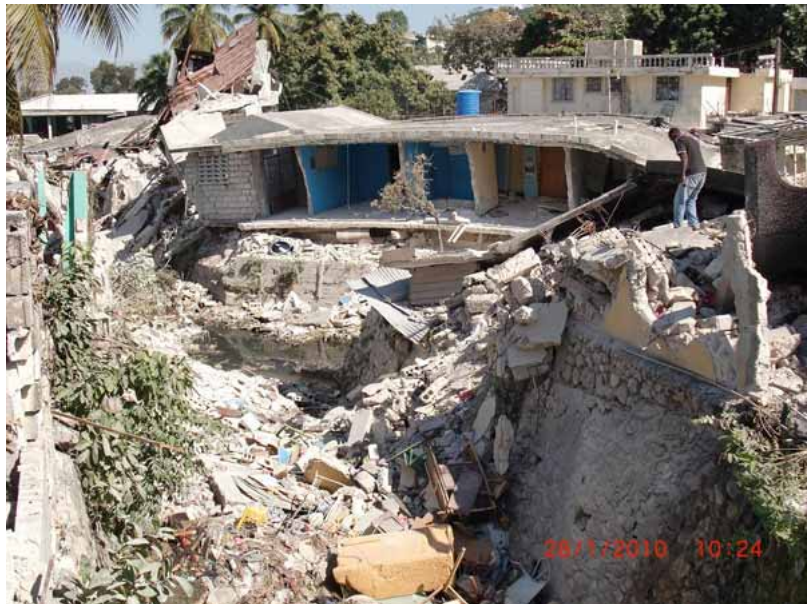
The collapse of municipal waste management services in the immediate aftermath of the earthquake led to the accumulation of everyday waste alongside disaster debris.

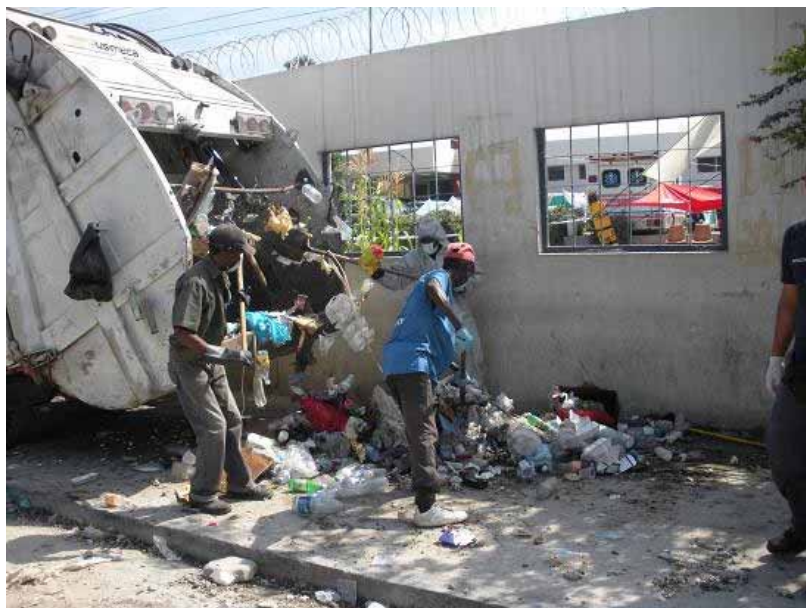
Municipal waste services have resumed across Port-au-Prince, although coverage is still limited.

Port-au-Prince has all the elements of a waste management system in place: skips placed across various parts of the city, a number of waste collection trucks, and a landfill where waste is collected and compacted. The system also has a number of informal features, however. As a result of incomplete collection by the municipal authorities, waste is often dumped across the city, in rivers and in the sea. In addition, there are a large number of on-site scavengers who collect any recyclable materials from the landfill prior to waste incineration.

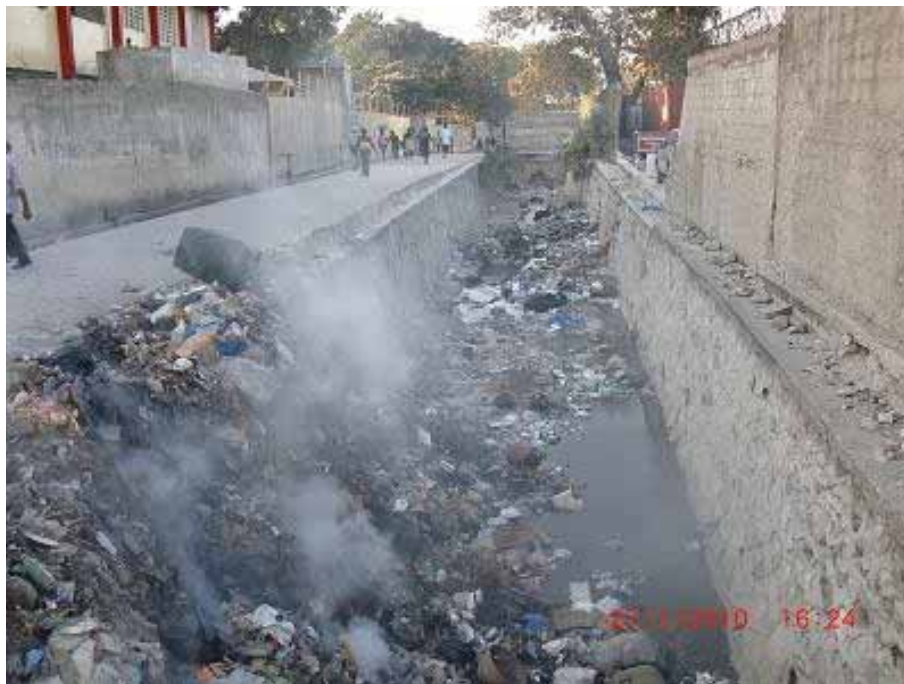
In many parts of Port-au-Prince, drainage channels are filled with solid waste. This causes localized flooding every time there is heavy rainfall.

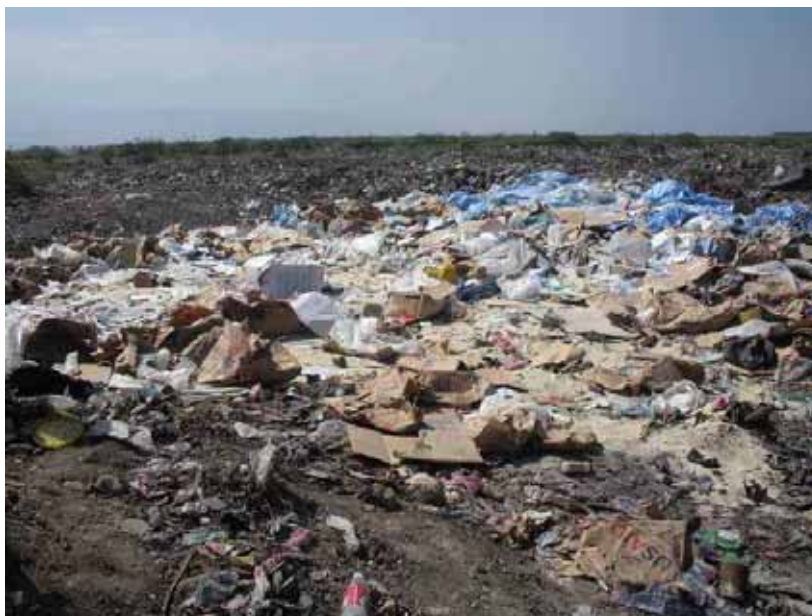
Post-disaster environmental damage is often exacerbated by the absence of effective mechanisms to dispose of the medical waste generated by emergency response operations.

This matter was discussed between UNEP, the World Health Organization (WHO), and the Haitian Government, and it was agreed that a temporary facility to dispose of medical wastes would be created within the municipal landfill in Titanye. A design for the same was provided and the facility was promptly constructed. Additional steps to train staff, equip them with the required personal protective equipment (PPE), and to provide suitable containers for the collection of healthcare waste were also agreed.

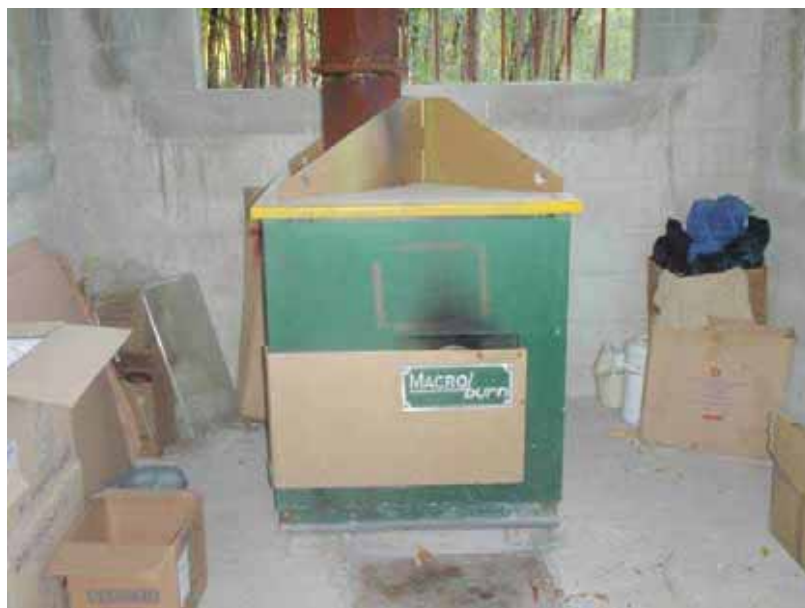
A number of hospital waste incinerators remained functional following the earthquake, aiding in medical waste management.

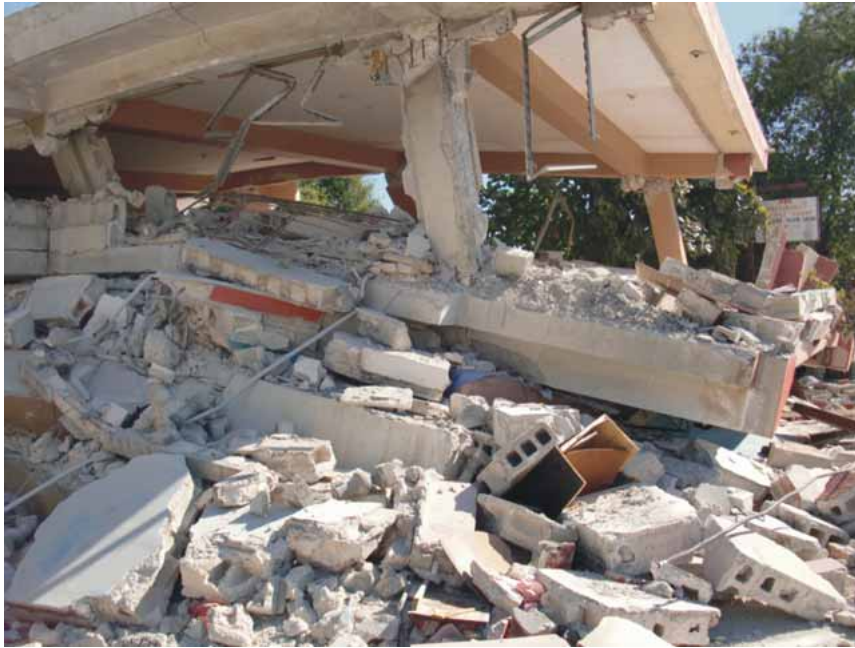
Concrete hollow bricks were often incorrectly used as load-carrying building material, and collapsed easily during the earthquake

First, limestone was used as a coarse and fine aggregate for making concrete for reinforced cement concrete structures. Unfortunately, limestone is not well suited for supporting heavy loads. Indeed it is clear from observations on the ground that a high proportion of lime in the concrete does not create adequate bonding to reinforcement bars. As a result, when the earthquake occurred, the concrete came off the reinforcement bars, making the columns and beams unstable and unable to behave as a single unit as designed, thereby failing the structure completely.

ensure better design factoring in all hazards, to decrease the dependence on limestone as the exclusive source of building construction material, and to develop and enforce building codes and quality control of building materials.

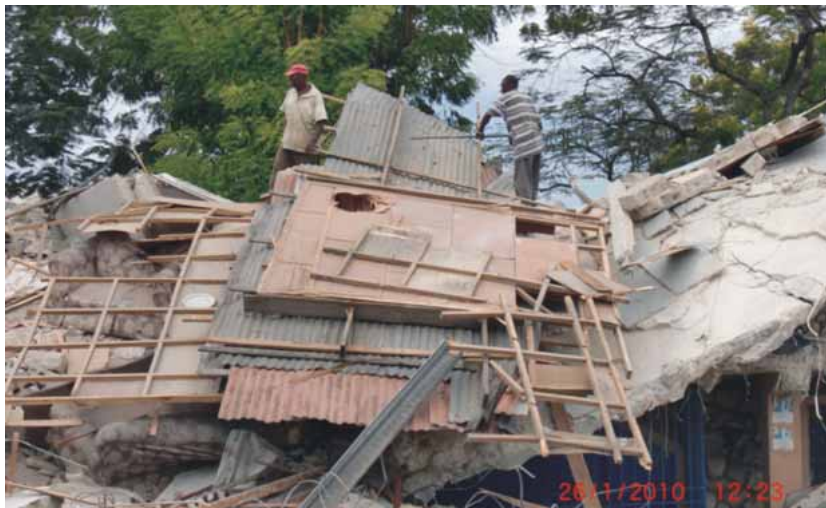
Disaster debris often contains a lot more than just brick and wood.

When the earth shook for 36 seconds on 12 January, all these structural elements were put to test – not only of static loads but also of dynamic stress. Hollow bricks, which were carrying loads they were not designed to carry, could not bear these additional stresses. Moreover, concrete which had little bonding with its reinforcement did not maintain cohesiveness. As the concrete came off, steel buckled, buildings collapsed, hollow bricks flew in all directions, and people were killed by the impact of falling debris, or crushed under their weight.

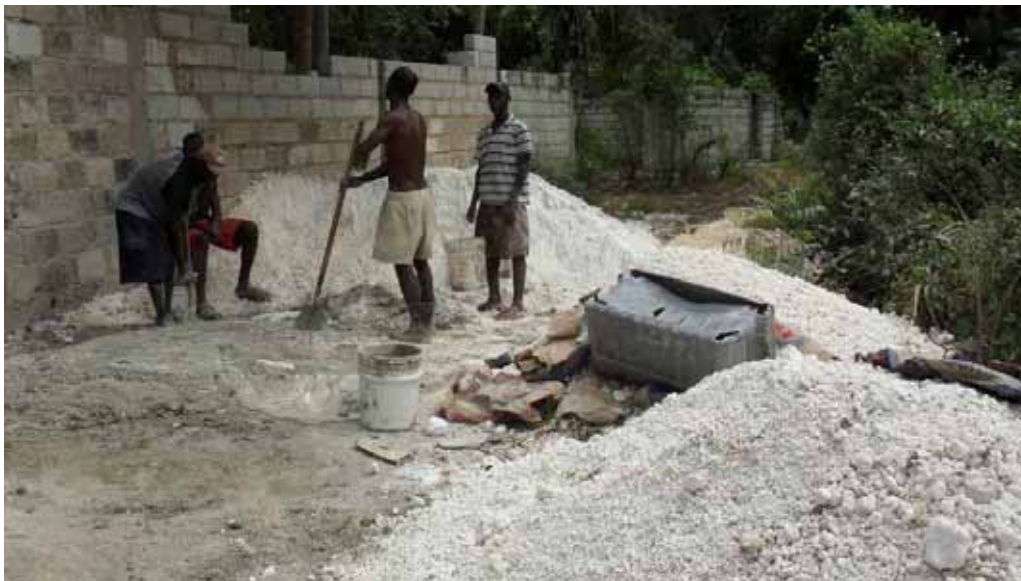
The use of existing approaches to making concrete will rebuild the same vulnerabilities into future construction.

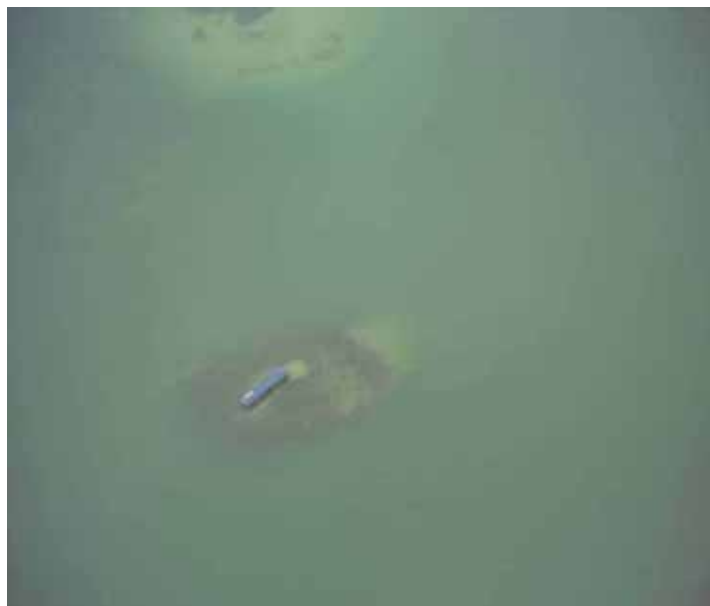
In the early days after the earthquake, two events provided cause for alarm. First, in the main port of Port-au-Prince, the collapse of the quays caused a number of containers to be washed

into the sea. Fortunately, there is no indication so far that these containers contained any chemical or harmful substances.

After the earthquake, a number of containers in the main port were washed out to sea, causing some concern for potential contamination.

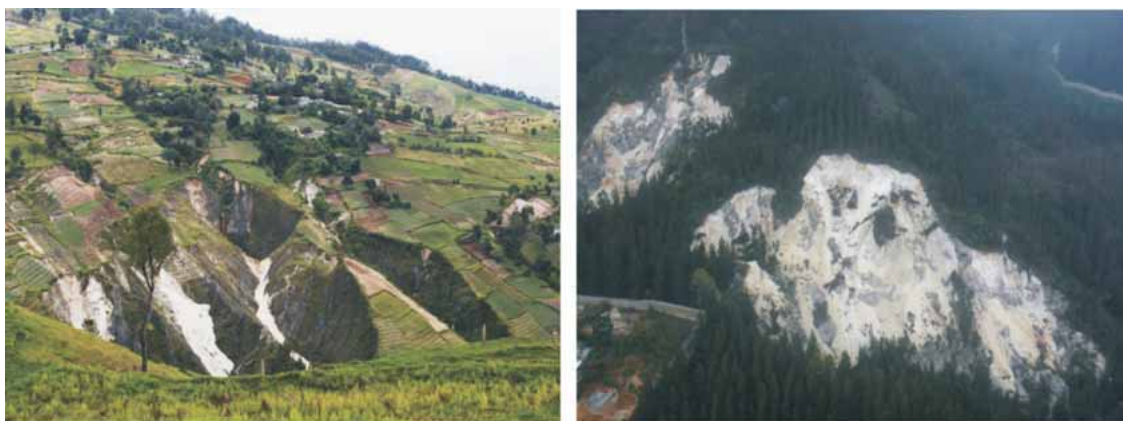
Before

After

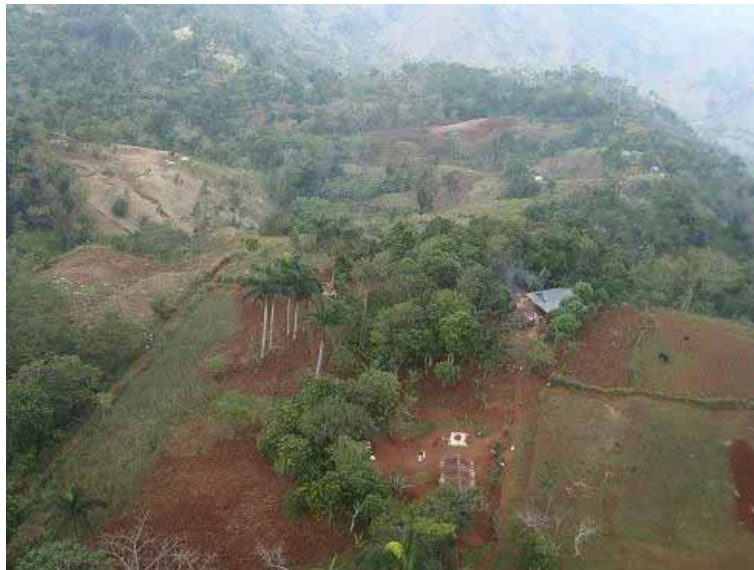
Significant soil erosion caused by deforestation reduces the ability of top soil to support vegetation.

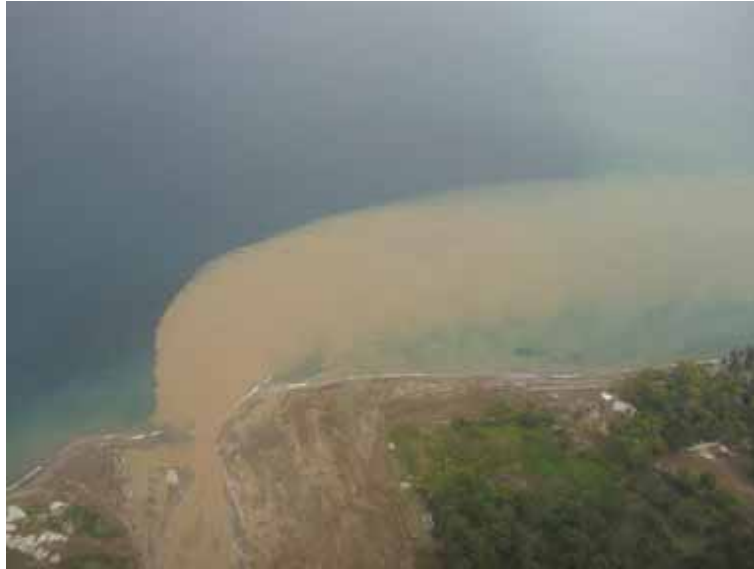
In addition, there will be a significant increase in sediment flows into the sea on both sides, leading initially to discoloration that will impact the natural beauty of the sea, and thereby likely impact on tourism. This excessive sedimentation will impact the mangrove forests in Petit Guave, the coral formations along both sides, and may also impact fisheries, at least in the shallow zone.

The upcoming rainy season is likely to increase sediment flows into the sea, potentially impacting mangrove forests, coral formations and fisheries.

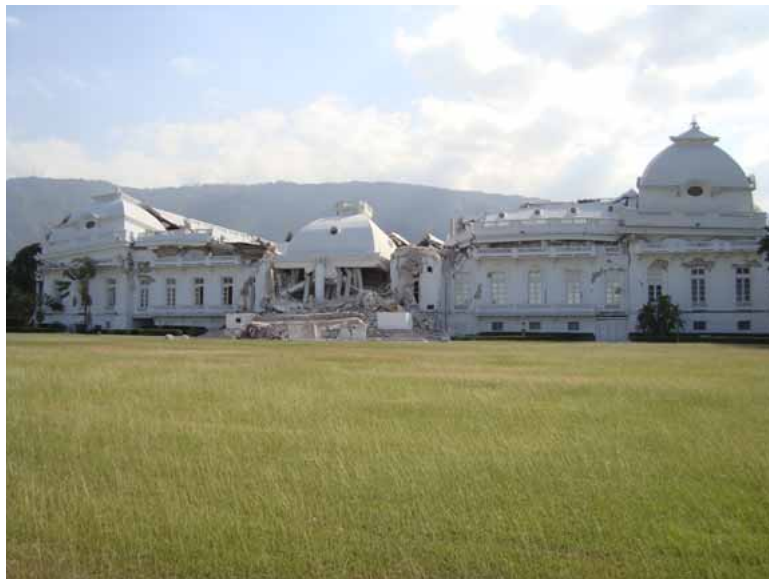
The presidential palace in Port-au-Prince was extensively damaged by the earthquake and will need to be demolished.

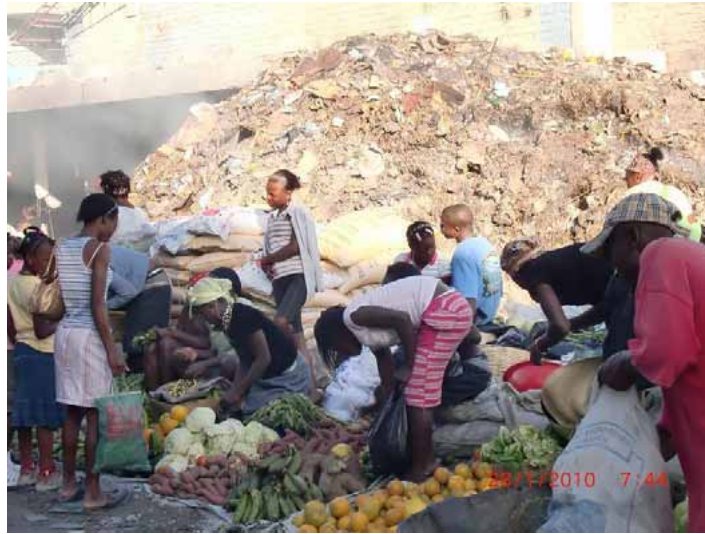
Vendors set up stalls all over Port-au-Prince, often within range of large uncollected waste piles.

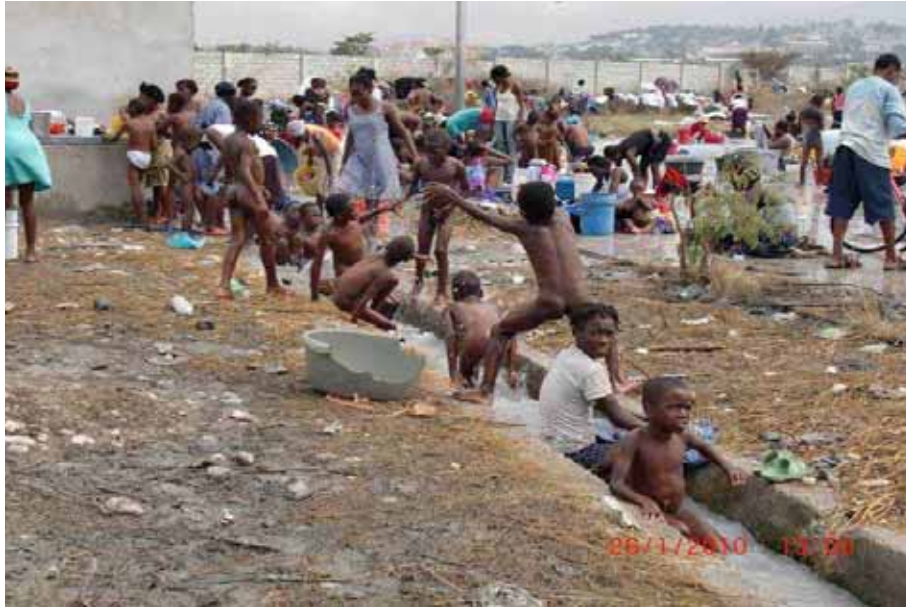
As the camps sprung up without any planning, no systematic provisions were made for sanitation facilities. There were no separate facilities for men and women – neither for showers nor for toilets – and as a result people bathed wherever there was water available, and were forced to use open spaces for toilets. Although the overall situation has started to improve with the establishment of temporary facilities and some clean-up work in progress, it is still not to at an acceptable standard. Whether existing campsites are converted into long-term facilities or decommissioned as new facilities become available, these areas will need to be cleaned up and sanitized.

In the absence of adequate sanitation facilities in the camps, children bathe wherever they can find water.

When new camps are established, a systematic approach to sanitation management must be adopted, including segregated toilets at an appropriate distance from places of habitation, regular collection of excreta, disposal of water from bathrooms and procedures for sanitizing the facilities at multiple daily intervals. In the Haitian context, particularly with the rainy season coming up, camp siting and development should make adequate provisions for a high rainfall scenario.

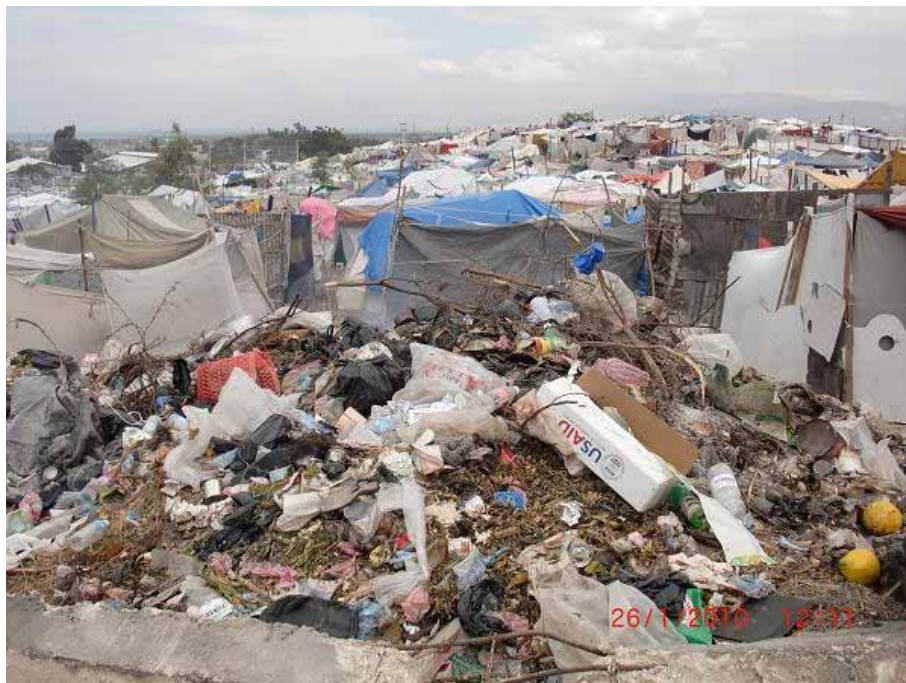
In addition to human waste, camps also produce the solid waste that can be expected from any human settlement. There is currently no designated area, collection system or disposal arrangement for solid waste management in the camps. Whenever proper camps are set up, these issues will need to be given due consideration as well.

The lack of solid waste management in IDP camps creates many health risks for residents.

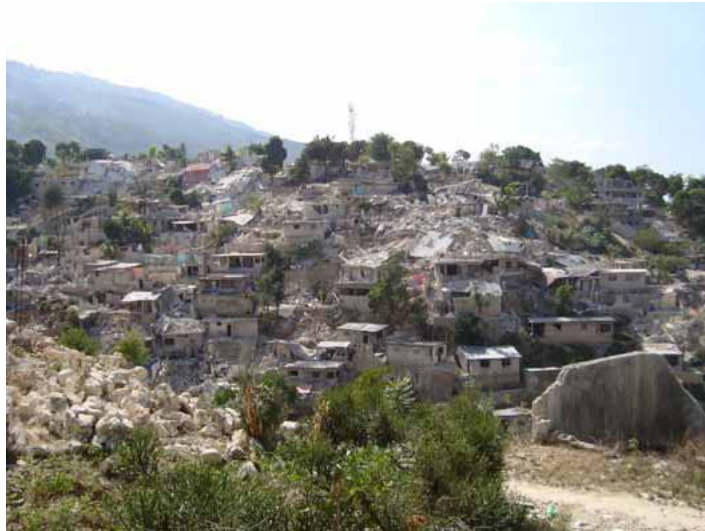
Most of the damage occurred in Port-au-Prince, particularly in the hilly areas. The existence of another fault line starting from the hills of Pétienville and of the seismic gap there, coupled with the increased likelihood of another earthquake triggered by an exacerbation of that fault line by the 12 January earthquake, rendered the location unsustainable. As a result, UN experts and local counterparts quickly ruled out rebuilding in the hilly Pétienville area.

The presence of a fault line beneath the hills of Pétionville makes the area unsuitable for resettling impacted populations.
